Uniform Mitigation Verification Inspection Form

| Inspection Date: 02/10/2020 | | |
| Address: 150 160 Evelyn Ct | | Home Phone: |

Wind Mitigation Photos

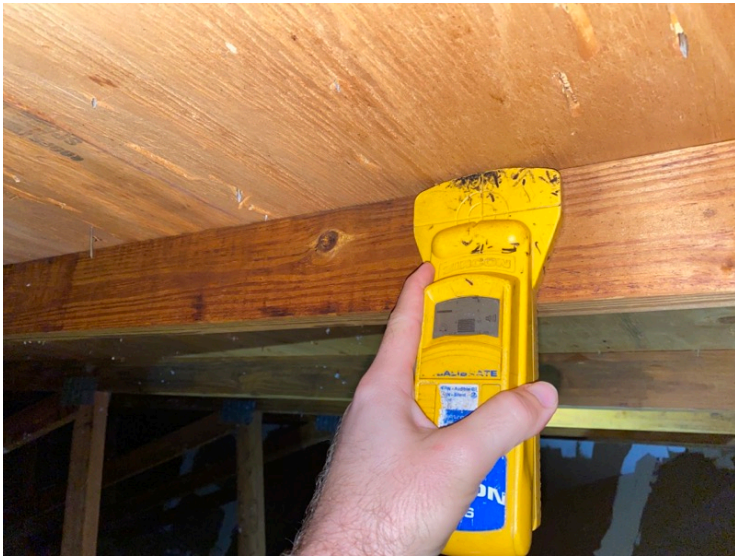
Roof Deck Attachment

MT6

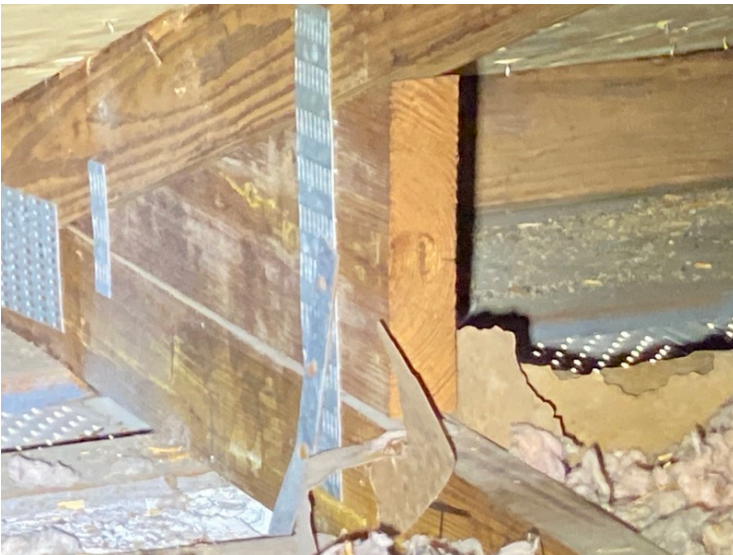
Roof To Wall Connection

Clips
