Uniform Mitigation Verification Inspection Form

Inspection Date: 02/10/2020		
Owner Information		
Owner Name: East Lake Woodlands Cluster Homes Improvement Association unit Four INC		Contact Person:
Address: 40 50 60 70 Colette Ct		Home Phone:
City: Oldsmar	Zip: 34677	Work Phone:
County: Pinellas		Cell Phone:
Insurance Company:		Policy #:
Year of Home: 1979	# of Stories: 1	Email:

Inspectors Initials RM Property Address 40 50 60 70 Colette Ct, Oldsmar, FL 34677

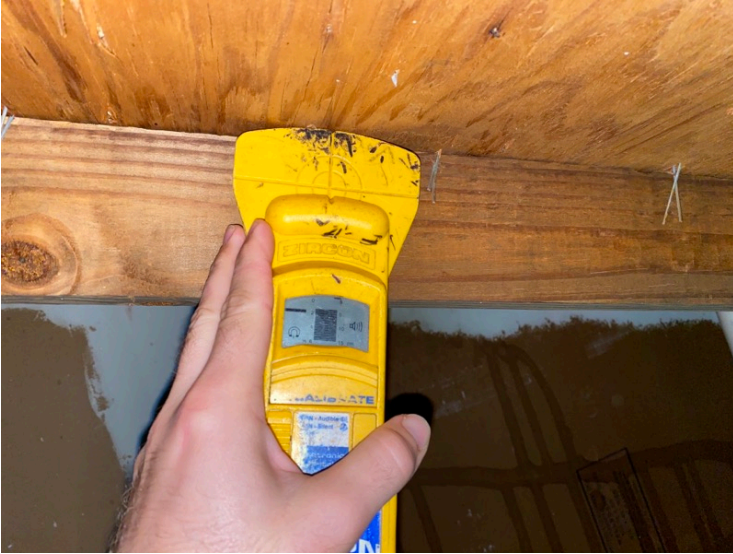
MT6

Roof Deck Attachment

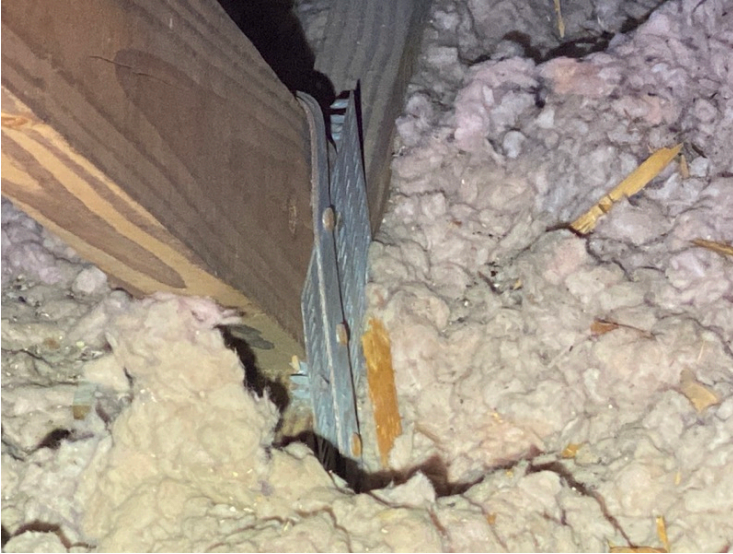
Roof To Wall Connection

Clips
