Uniform Mitigation Verification Inspection Form

Inspection Date: 02/10/2020		
Owner Information		
Owner Name: East Lake Woodlands Cluster Homes Improvement Association unit Four INC		Contact Person:
Address: 130 140 150 Colette Ct		Home Phone:
City: Oldsmar	Zip: 34677	Work Phone:
County: Pinellas		Cell Phone:
Insurance Company:		Policy #:
Year of Home: 1979	# of Stories: 1	Email:

Wind Mitigation Photos

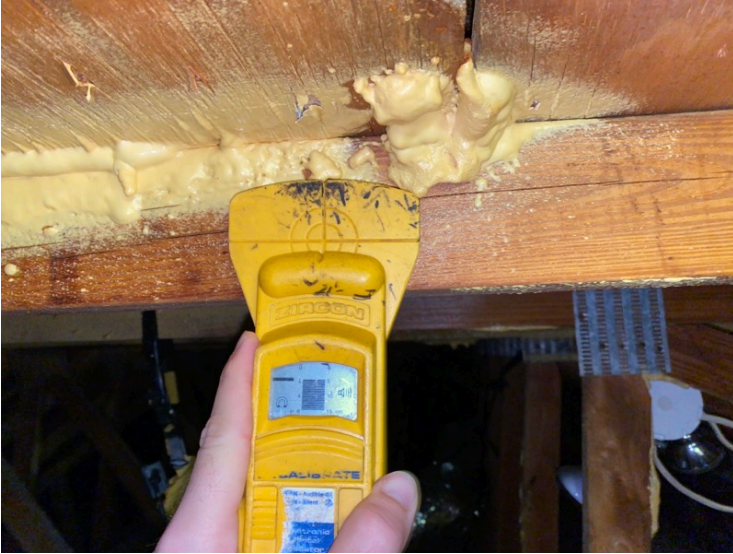
MT6

Roof Deck Attachment

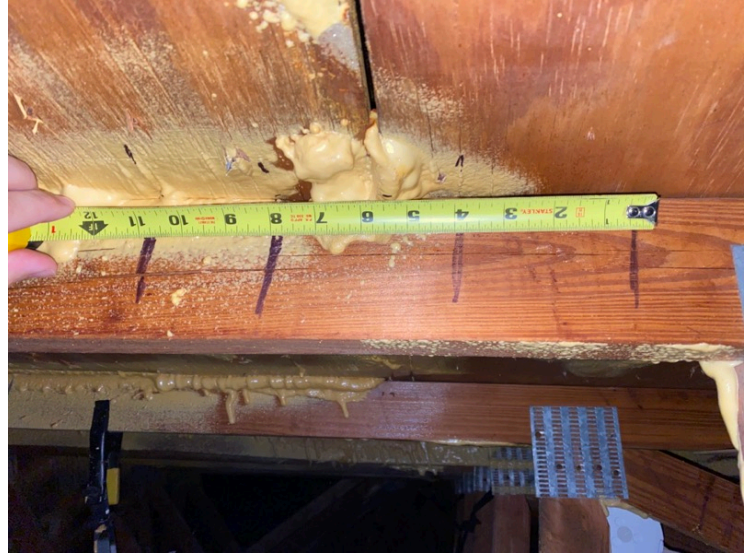
Nail Spacing

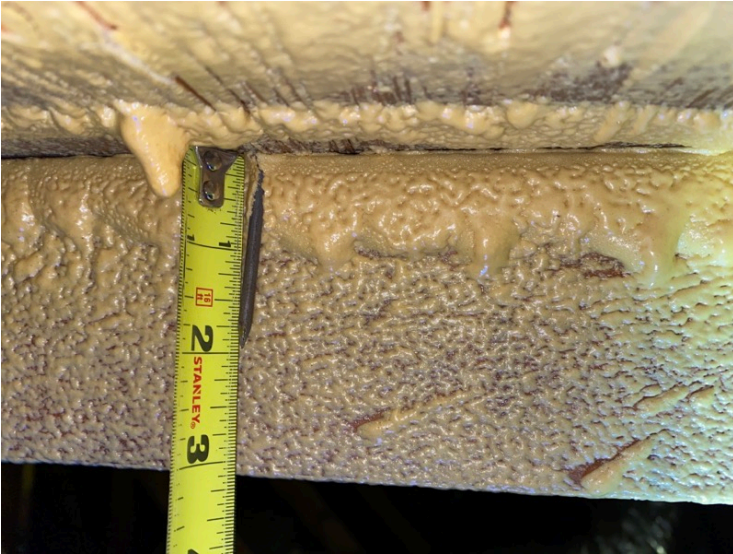
Nail Type

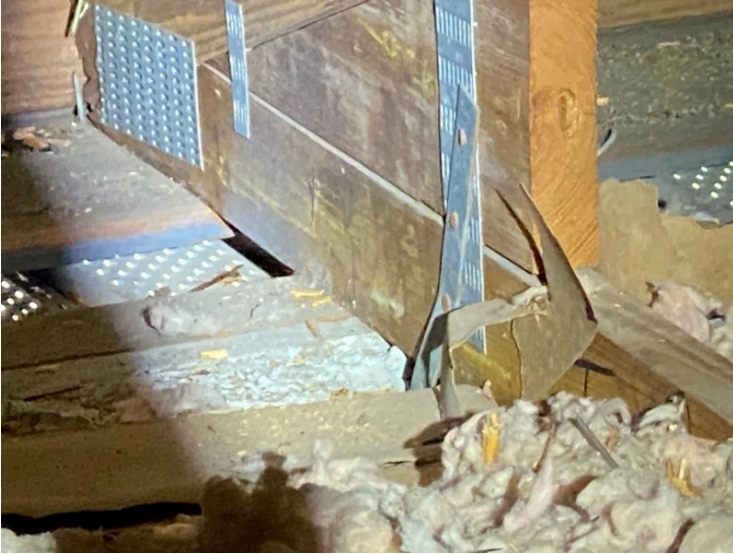
Roof To Wall Connection

Clips
