Uniform Mitigation Verification Inspection Form

Inspection Date: 5-18-20		
Owner Information East Lake Woodlands Cluster Homes Improvement Association unit Four INC		
Owner Name:		Contact Person:
Address: 10 20 30 TADS TRL		Home Phone:
City: Oldsmar	Zip: 34677	Work Phone:
County: Pinellas		Cell Phone:
Insurance Company:		Policy #:
Year of Home: 1979	# of Stories: 1	Email:

Wind Mitigation Photos

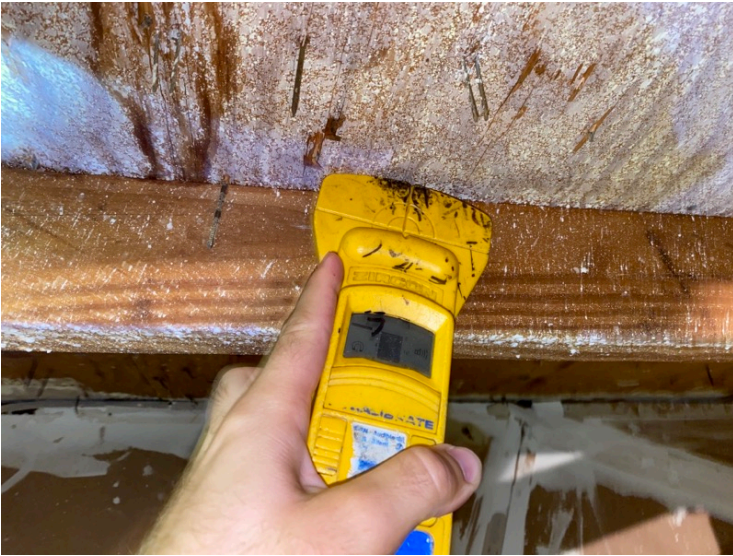
MT6

- Roof Deck Attachment:** What is the weakest form of roof deck attachment?

Roof Deck Attachment

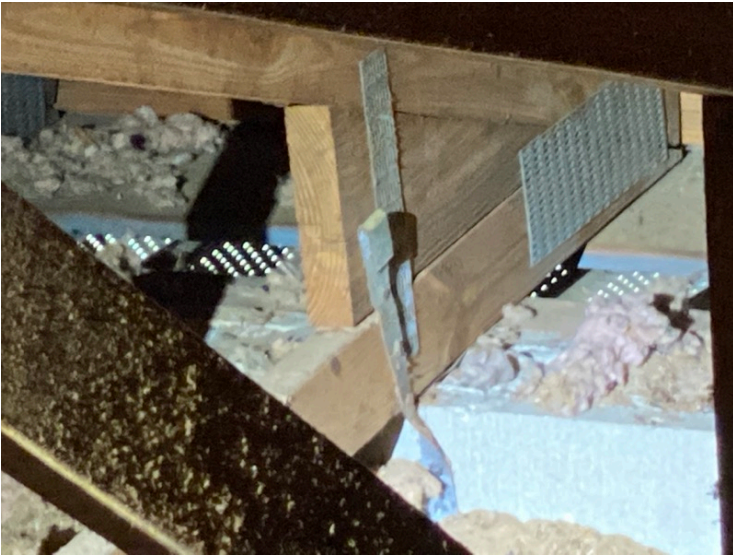
4. **Roof to Wall Attachment:** What is the **WEAKEST** roof to wall connection? (Do not include attachment of hip/valley jacks within 5 feet of the inside or outside corner of the roof in determination of WEAKEST type)

- B. Clips
 - Metal connectors that do not wrap over the top of the truss/rafter, **or**
 - Metal connectors with a minimum of 1 strap that wraps over the top of the truss/rafter and does not meet the nail position requirements of C or D, but is secured with a minimum of 3 nails.

Roof To Wall Connection
